ANALYSIS OF FAILURE CONDITIONS FOR A DYNAMICALLY LOADED COMPOSITE FLOOR SYSTEM OF AN INDUSTRIAL BUILDING

Abstract. Results of examination and analysis of cracks formation in a composite slab floor in an industrial warehouse hall is presented in the paper. During exploitation of the floor, on which lift trucks and presses worked, a lot of deep cracks occurred in the slab. In order to define characteristics of cracks and properties of concrete there were made different NDT examinations. Measurements of vibrations due to work of presses were also realized with aim to evaluate their possible influence on cracks formation. Static, dynamic and strength structural calculations were also made based on the model of continuous, multi-bay plate. They showed that applied slab reinforcement was sufficient and acting loads did not have to cause cracks. After 3D modelling of the building and taking into consideration the flexibility of main steel beams it was gained that in the RC floor slab over supports bending moments could occur nearly three times greater than calculated from the 2D model. Taking into consideration wrong structural model of the building led to over-loading of the floor slab,

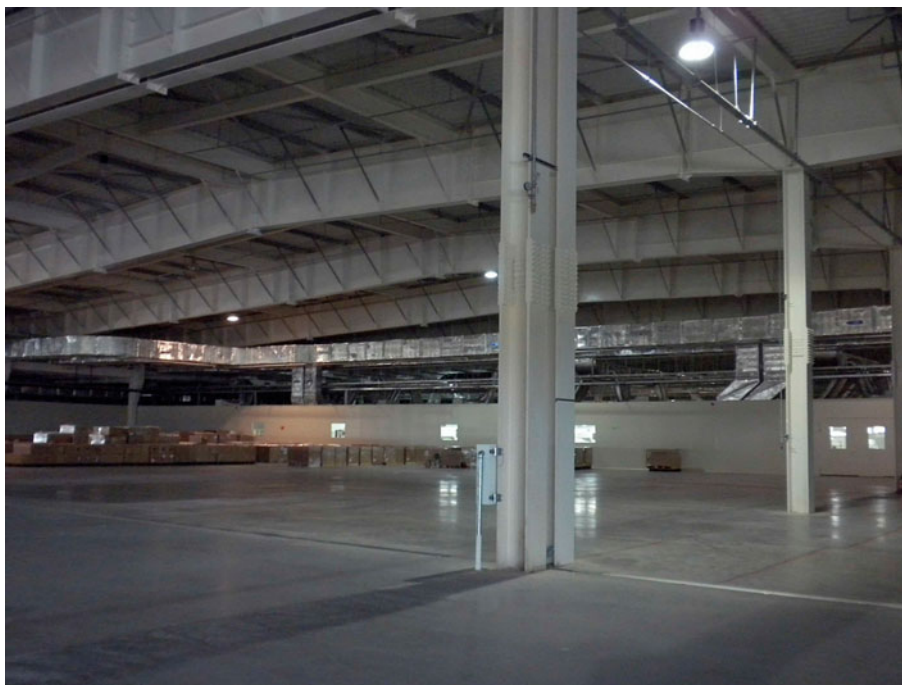
Fig. 1. General view of steel-bearing structure of the industrial hall

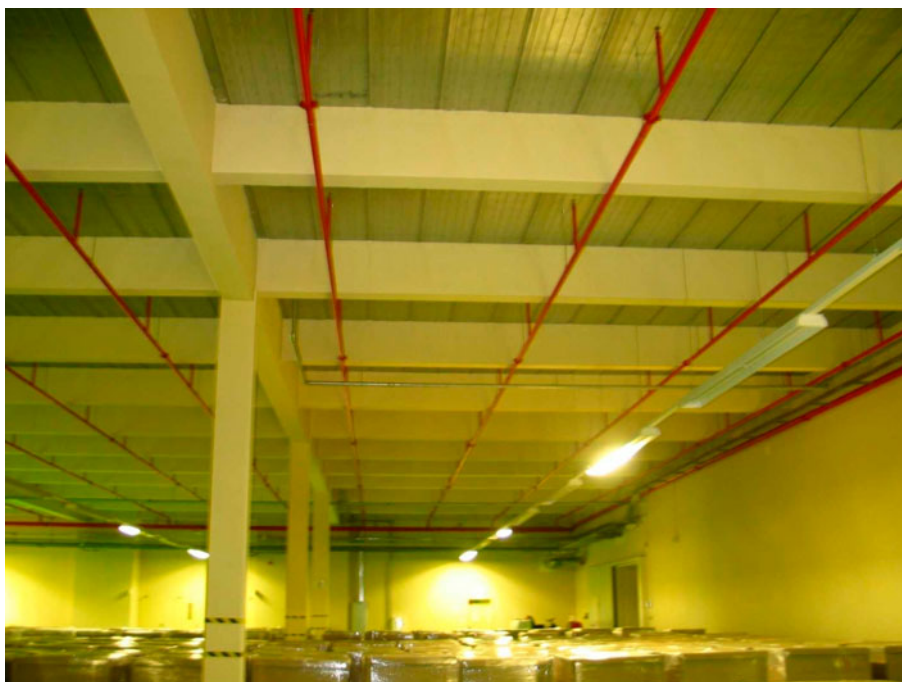
These beams were used to construct the steel/reinforced concrete floor system under investigation (Fig. 2). Main binding joists with the span of 8.0 and 9.2 m have a cross-section of $700 \times 300 \times 13 \times 24$ mm, those with the span of 9.5 m – $792 \times 300 \times 14 \times 22$ mm, and those with the span of 10 m – $800 \times 300 \times 14 \times 26$ mm. The

floor system beams are 10.0 m long and their cross-section is $606 \times 201 \times 12 \times 20$ mm. Dimensions of cross-sections are given according to design documentation available and are verified by measurements taken.

Fig. 2. View of the system of main and secondary floor beams

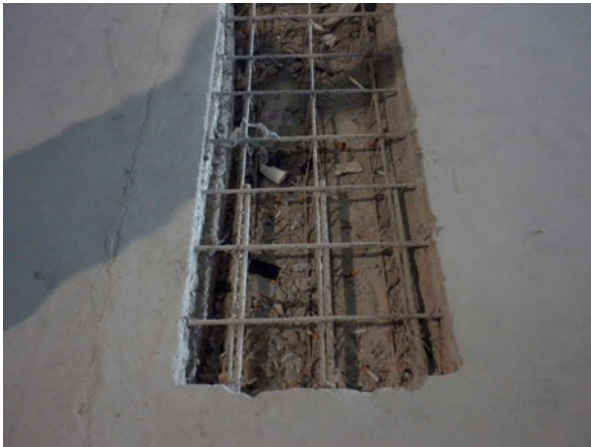
Fig. 3. View of the spatial trusses of composite deck slab

prefabricated spatial trusses welded to a troughed sheet laid on steel carrying girders (Fig. 3).

Lower bars of trusses are of diameter $d=8$ mm, and the upper bars are of $d=10$ mm. These bars are interconnected with diagonal braces $d=5$ mm in diameter.

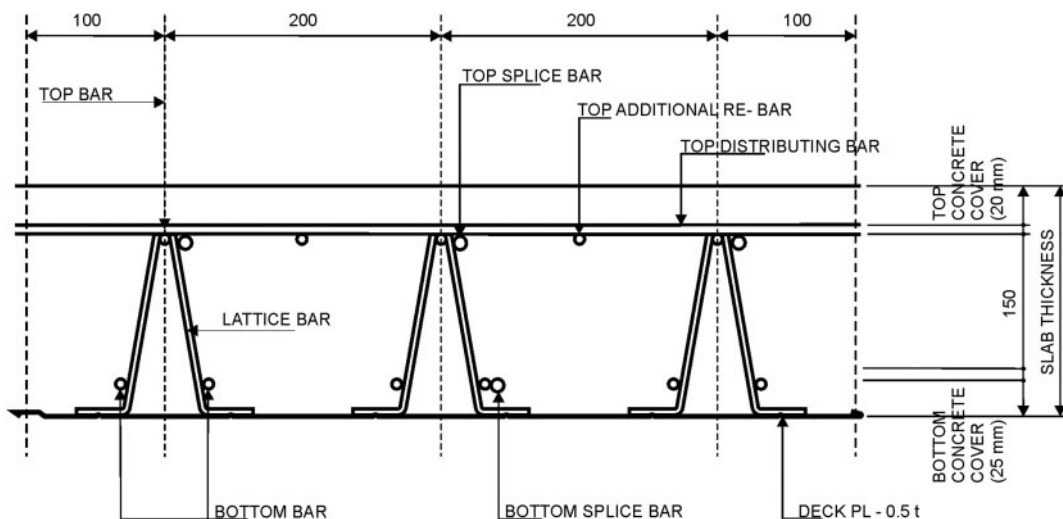
A grid of bars $d=10$ mm and mesh 20×20 cm is added. Over the floor beams, additional bars, $d=14$ mm were placed on the top, with the reach of 40 diameters beyond the beam axis. The design and real thickness of the deck plate in the hall area under consideration is 15 cm (Fig. 4).

Fig. 4. Cross-section of the typical composite deck plate

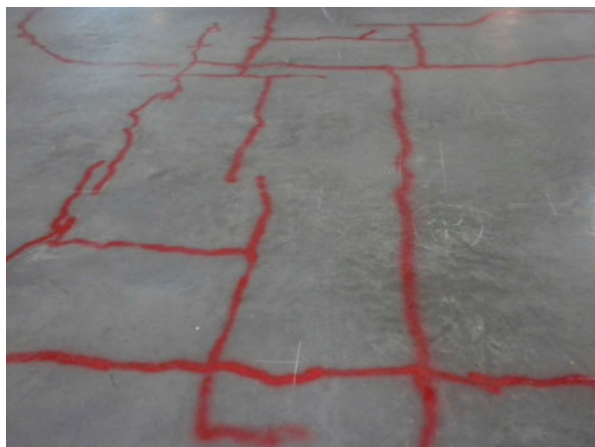
As a result of these operational loads, the deck plate of the hall, in the outlined area and in adjacent fields, sustained extensive cracks (Fig. 5). Following the occurrence of cracks in the deck, some warehoused products were removed from it and the fork-lift trucks were eliminated.

In the course of operation, a large number of cracks were found in the floor system under examination. These cracks formed at the top surface of the deck slab and most often were located in parallel to the floor ribs and main beams (Fig. 5). There were also cracks transverse to the floor beams and a substantial number of cracks run along the reinforcement lines of deck slabs.

Measurements of crack openings and their depth were taken using Impact-Echo method during examinations. According to these measurements, the crack opening was up to 1.6 mm , hence it was much higher than the admissible value of 0.3 mm .

Fig. 5. View of the situation of cracks in concrete floor slab

The cracks in the deck plate under examination were caused by a reinforcement and deck plate thickness that were mismatched to the designed level of operational loads of 8 kN/m². On the other hand, the steel components of the deck plate, that is, beams and binding joists are of a sufficient design loading capacity for the assumed level of operational loads. Presumably, when the deck plate of the building was designed, the influence of the steel deck plate beam flexibility on the distribution of forces in the RC slab was not taken into account, causing an almost twofold underestimation of the values of support moments.

As it is necessary to prevent the occurrence of new cracks and due to the discontinuity of plates in the cracked areas, the maximum operational load of the deck plate was established at 4 kN/m², with the influence of the steel beams of the deck plate on redistribution and values of bending moments in the deck plate taken into account in the calculations. It was also decided not to allow fork-lift trucks to drive over the deck plate.

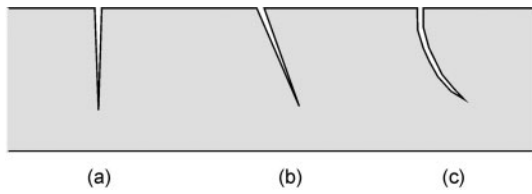
The depth of superficial cracks (Alam *et al.* 2012; Breysse *et al.* 2011; Głodkowska 2011; Łowińska-Kluge, Błaszczyński 2012) was also examined during testing. Figure 6 illustrates the characteristic geometry of superficial cracks, while Figure 7 shows the scheme

Fig. 6. Scheme of the characteristic geometry of cracks (Sansalone, Streett 1997): (a) perpendicular; (b) inclined; (c) curved

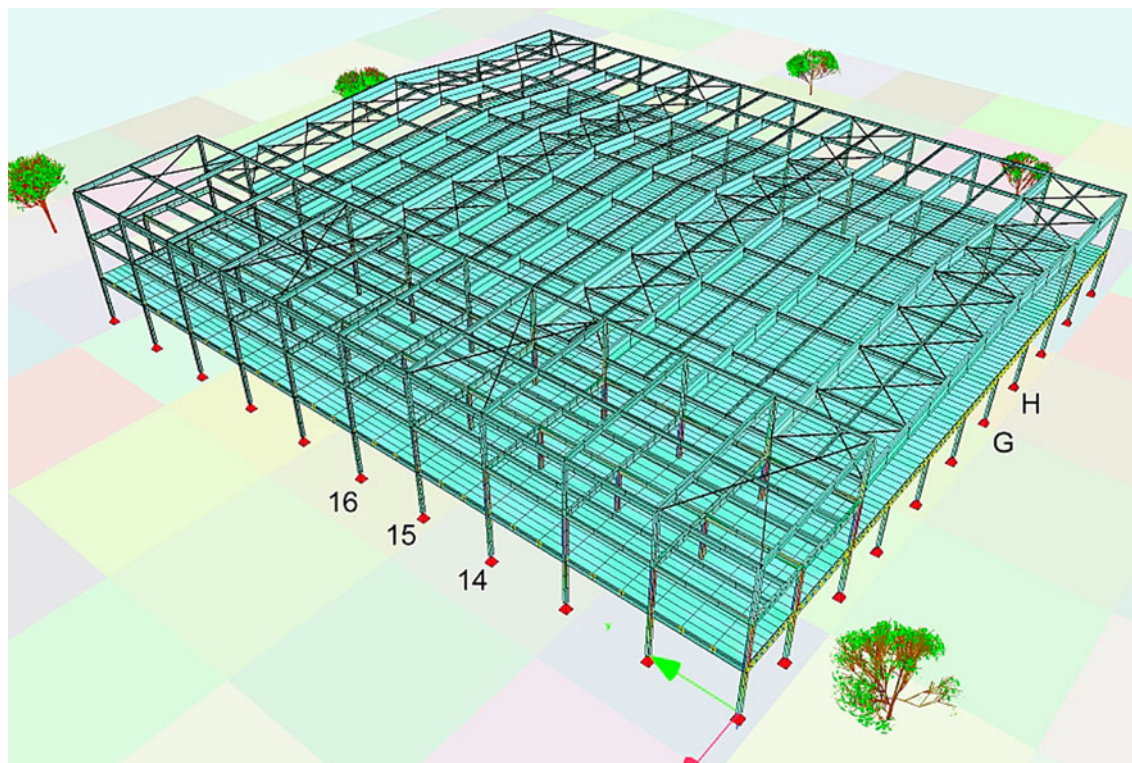
Fig. 9. General computer model of the industrial hall

Also, a dynamic analysis was performed for the whole structure (Fig. 9) using the finite element method, which results are presented in Chapter 6.

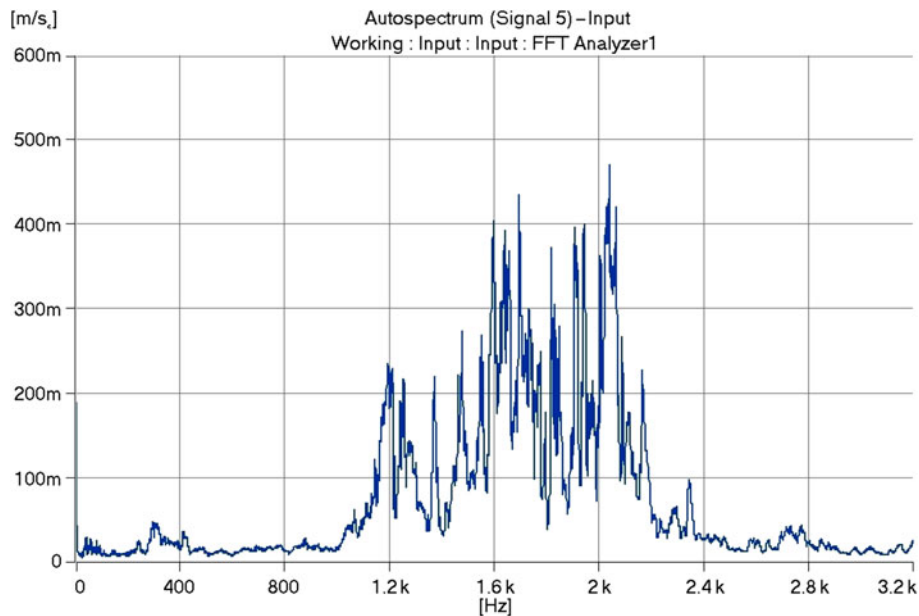
Fig. 10. Autospectrum of Signal 5, vibration of the working press number 2

Figure 10 illustrates autospectrum of accelerations measured on the running machine. The frequencies

within 1000–2200 Hz are dominating, and the maximum acceleration values found exceed 100 m/s^2 .

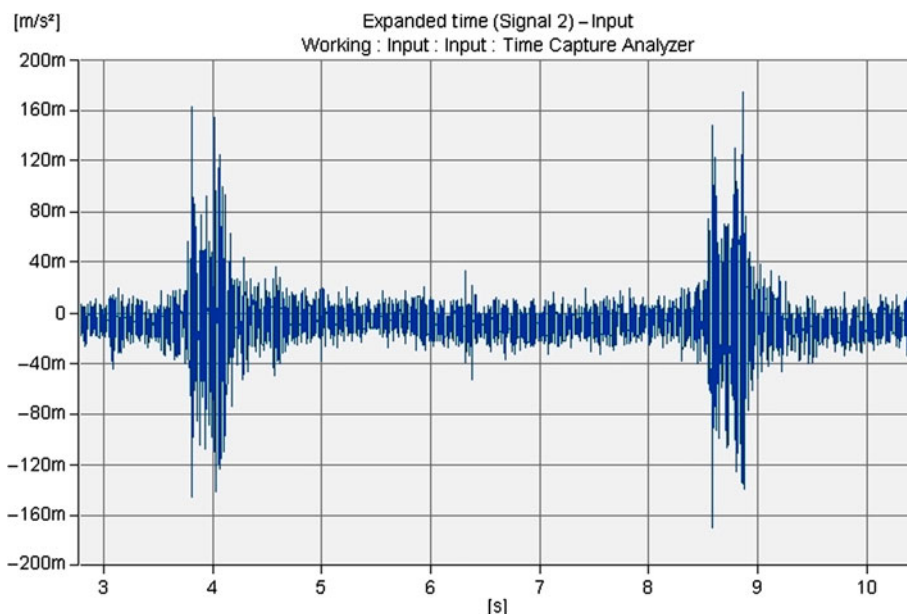
Accelerations measured on the deck plate structure close to the machine supporting point were definitely lower – up to 2 m/s^2 . The nature of vibrations is shown in Figure 11. The periodical pulse nature of the input function is visible. The time distance between excitation pulses is 4.8 s.

Fig. 11. Acceleration measured on the press 2 (Signal 2)

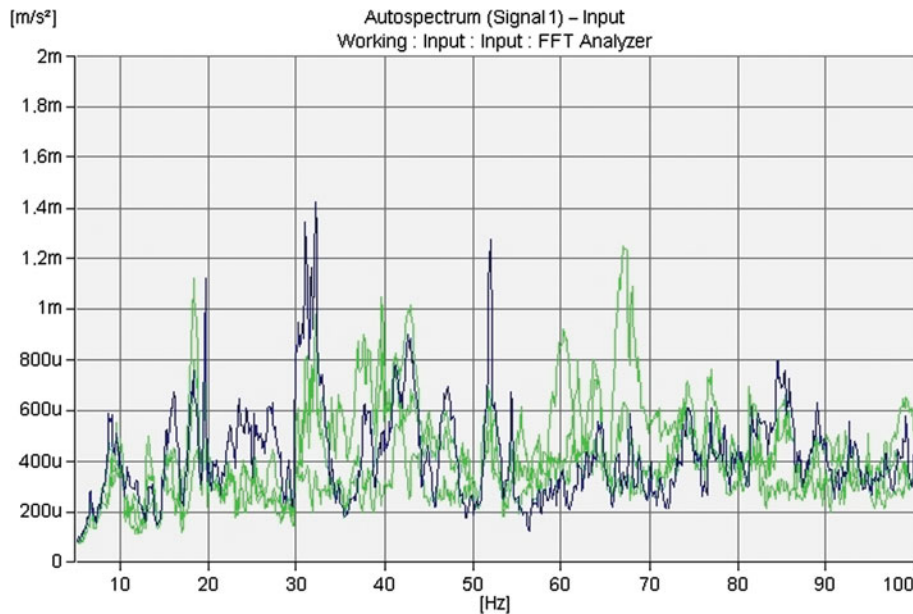
As it can be seen, vibrations are subject to amplification in the system around 8–9 Hz; 18–20 Hz; 31–35 Hz; and 55 Hz (Fig. 12).

Fig. 12. Autospectrum of signals in bandwidth 5–100 Hz (Signal 2 – blue line)

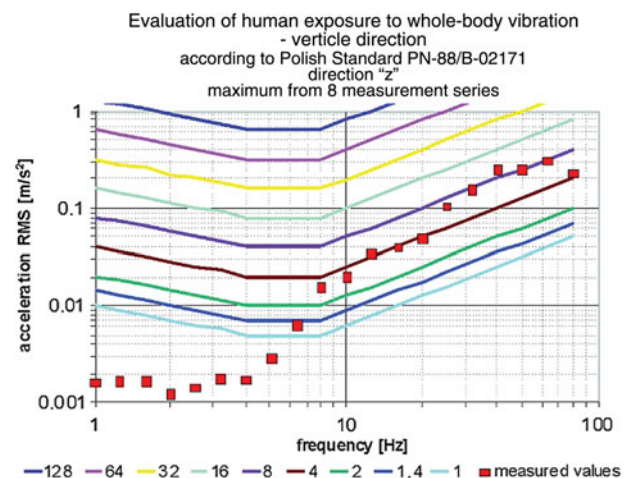
results of the third analysis are shown in Figure 13. In thirds 8–80 Hz, vibrations exceed the human being perception threshold, whereas in the 40 Hz third, this threshold is exceeded over eightfold.

These are vibrations with the level higher than that admissible by the standard PN-88/B-02171:1988 in working plants for continuous vibrations.

Fig. 13. RMS of acceleration – 1/3 octave analysis on the background of human sensitive limits

Due to the vibration level causing discomfort to workers and furthering the development of cracks, a recommendation was made to move the presses from the second storey to the first. As an alternative solution it was proposed to strengthen the second storey slab and use appropriate dampers for presses.

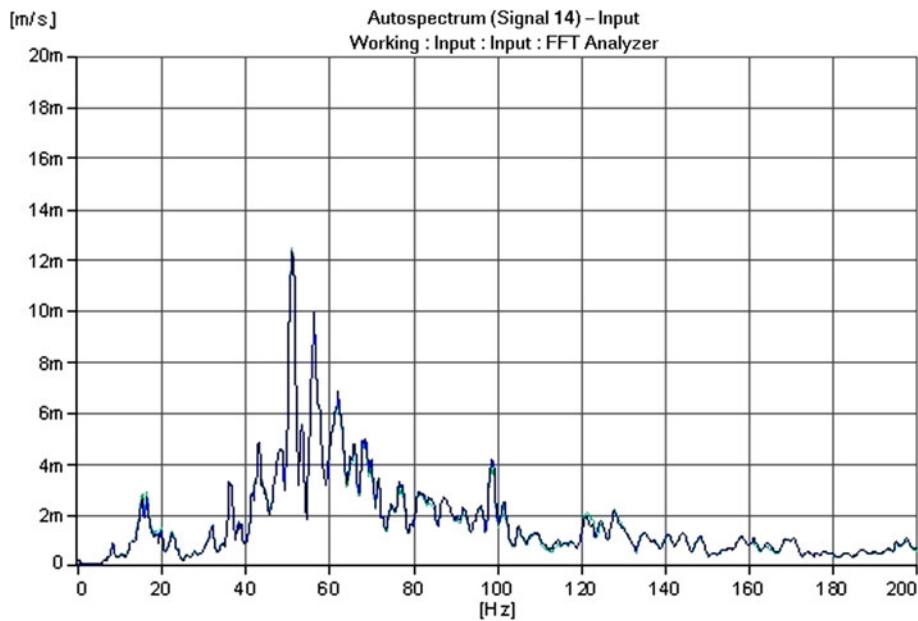
The spectrum of accelerations is shown in Figure 14. Small differences in the autospectrum suggest the conclusion that the crack ‘does not operate dynamically’, that is, the cracks were not created by dynamic effects.

Fig. 14. Autospectrum of two signals measured on both sides of the crack

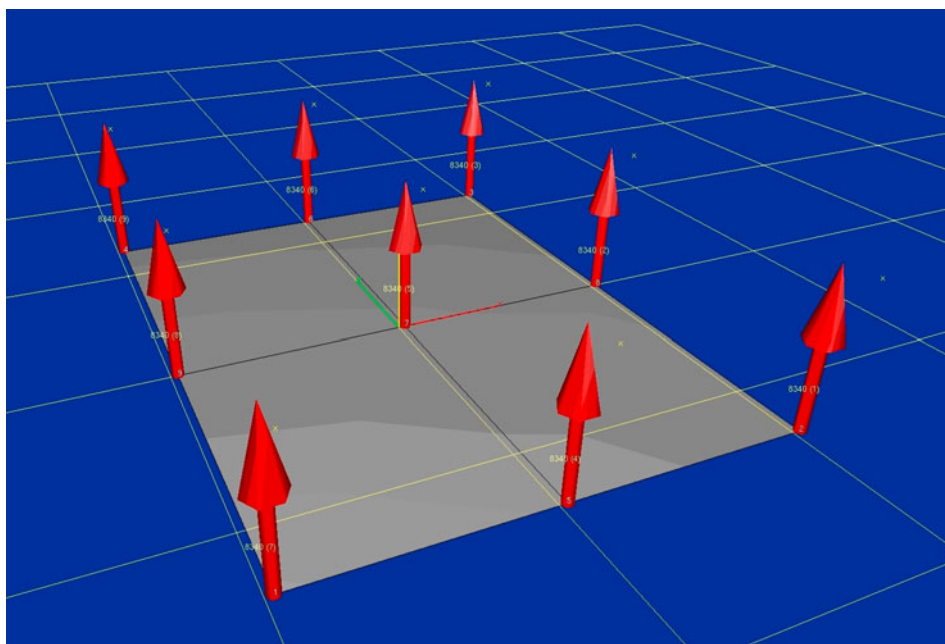
The Operational Modal Analysis for the structure segment in the rectangle marked out by the G–H axes and the 14–15 axes (Fig. 8) was also carried out in the Stage 2; here the accelerometers were placed in the 3×3 wall (Fig. 15). The values of accelerations

Fig. 15. Position scheme of 9 accelerometers during Operational Modal Analysis (OMA)

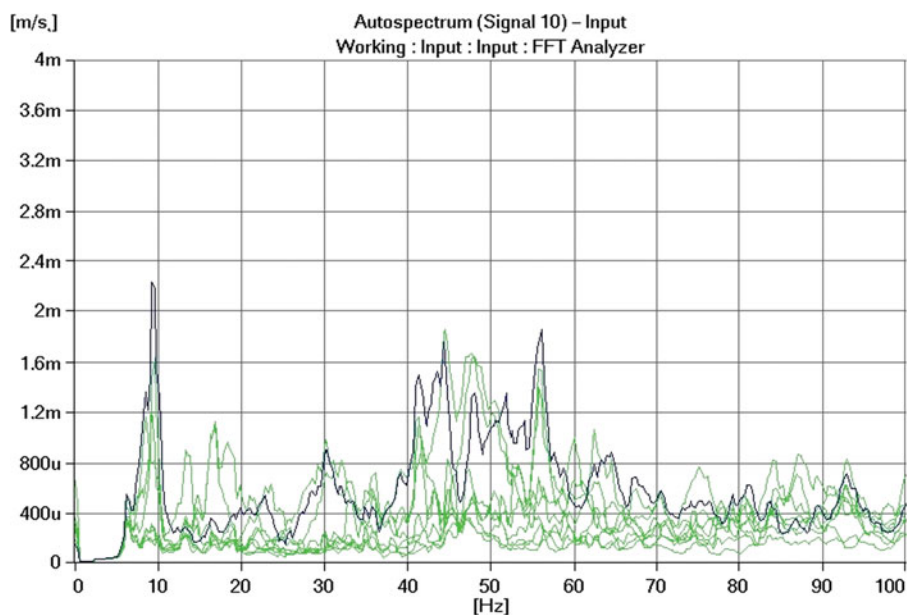
Figure 16 illustrates the autospectra of acceleration in the bandwidth 0–100 Hz. Intensification is visible close to the frequency of 9 Hz.

Fig. 16. Autospectrum of acceleration measured on the concrete floor slab, bandwidth 0–100 Hz (Signal 10 – blue line, the other signals – green lines)

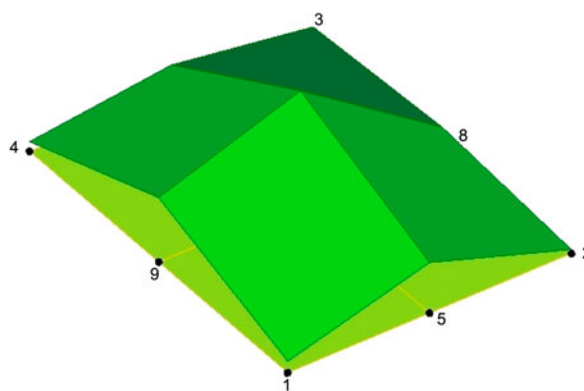
To run the modal analysis, the software package of SVS Company, Denmark, was applied and Frequency Domain Decomposition was used. The form for fundamental vibration frequency is shown in Figure 17. Following a series of measurements, it was finally ascertained that the value of eigenfrequency of the floor slab is 9.27 Hz.

Fig. 17. Identified eigenshape for the fundamental eigenfrequency (9.27 Hz)

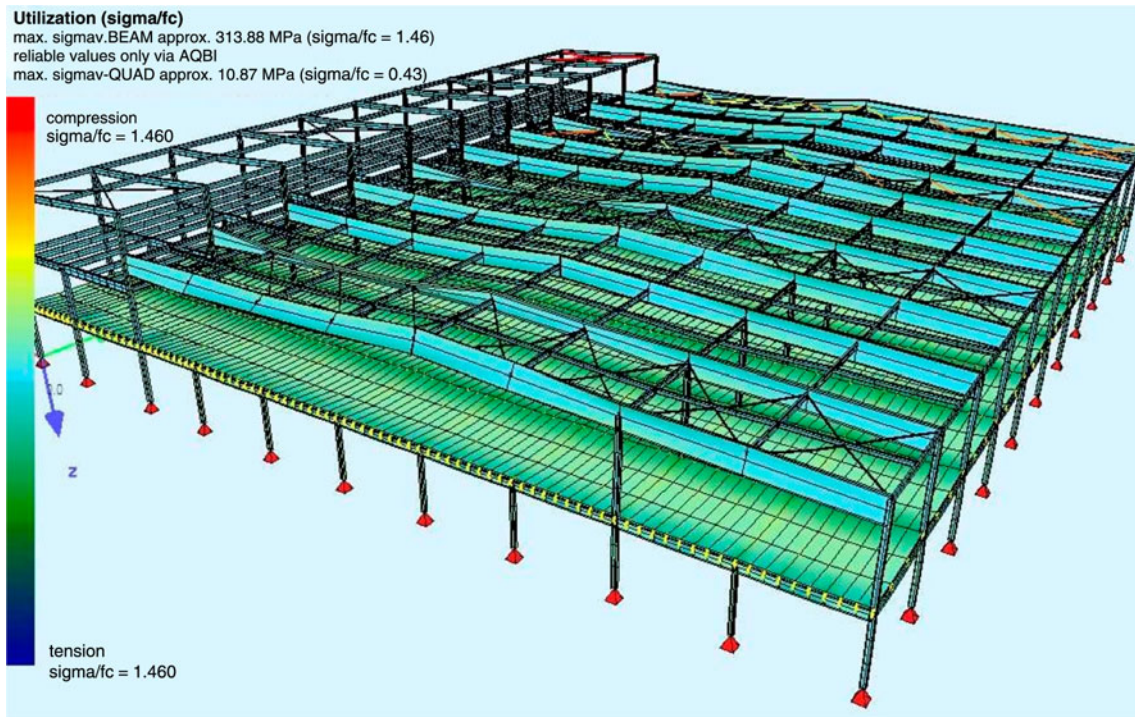
Detailed calculations proved that while the reinforcement is sufficient along the axis of supports, the moments, just beyond the zone of additional reinforcement influence, are so large that they could cause cracks in the deck plate top surface with the opening about 0.52 mm wide, so in practice twice as large as those admissible, which amount to 0.3 mm. Taking into consideration the additional load from the fork-lift truck and the presses, the deck plate cracks could amount up to 0.7–0.86 mm. The

Fig. 18. Example of the stress results for structural analysis

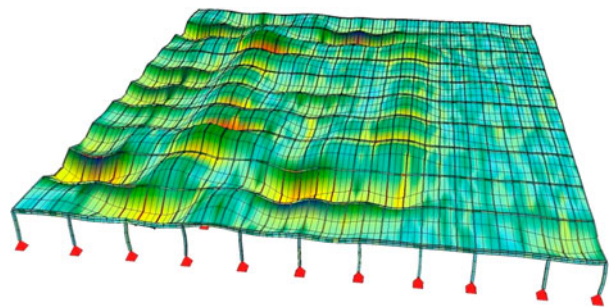
Computer calculations of the dynamics of the whole structure were also performed (Figs 19 and 20) and the results were compared with real measurements of eigenvalues of the loaded deck plate for various loads and working conditions (Section 4).

Fig. 19. Example of the results of dynamic calculations for eigenvalue 6.56 Hz

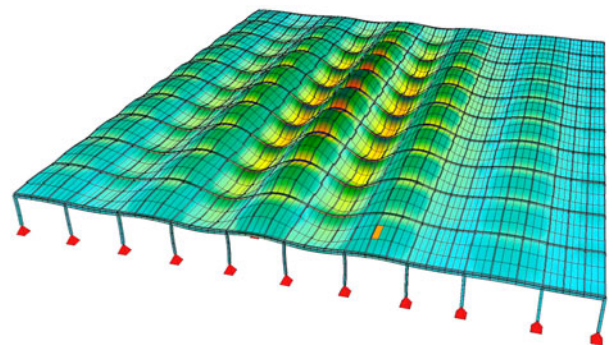
Fig. 20. Example of the results of dynamic calculations for eigenvalue 5.91 Hz
