THE TRUCK TRAILER SUSPENSION AXLES FAILURE ANALYSIS AND MODELLING

Jurijus TRETJAKOVAS¹, Audrius ČEREŠKA^{2*}

The purpose is to determine the nature and causes of failures of the suspension axles of truck trailers and to perform modelling of the suspension axle deformations using the FEM.

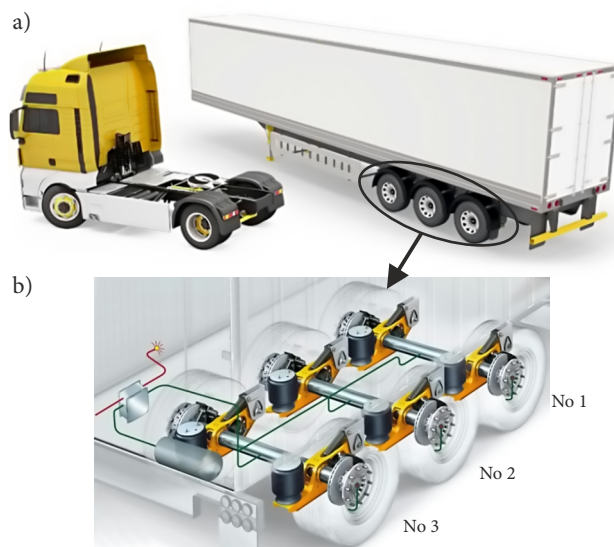
Figure 1. Truck with trailer: a – general view; b – trailer suspension

The object of the research is an axle of the truck with a three-axle trailer (Figure 1).

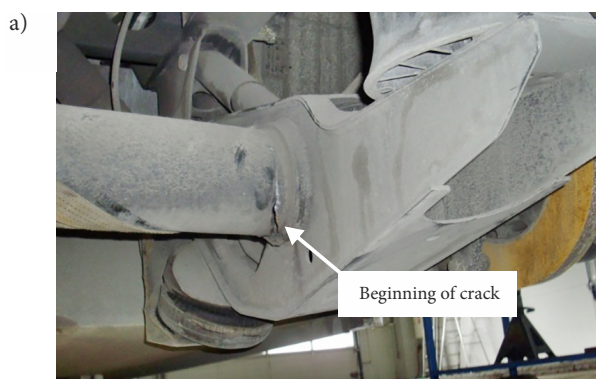
Figure 5. Axles: a – the beginning of the crack; b – crack at the mounting position

After some exploitation, axle primary failures appeared (Figure 5a). Axle failure began to develop from minor cracks in crack focus (Figure 5b).

From the photos (Figures 5 and 6), it is visible that minor faults (small cracks in Figure 5) turn into serious failures (Figure 6).

On the basis of these studies mentioned above the mechanism of crack development will be described. The visual examination of the focal lengths and fractures of the axis crack (Figures 5 and 6) showed that the crack nucleus is the most often formed at the weld seam of the axis joint (Figure 5b).

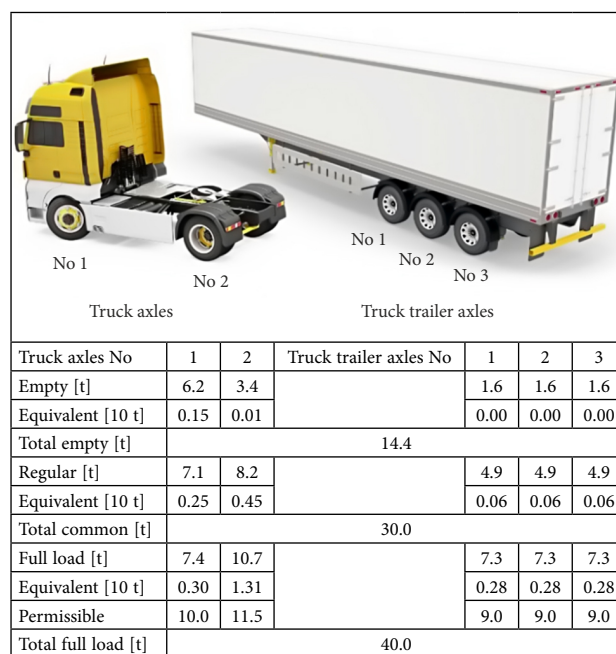
Figure 7. Loads distributions to axles

The loads of the axle were defined according to Koval’ (2017) and transportation case with fully loaded trailer (Figure 7) with permissible loads was taken into account. According to Figure 7 performance axle capacity for solutions and modelling is 9000 kg. Certainly, this load is not exact, because the dynamics effect in roads with defects will increase this value. For this reason, different loads for different axes are not defined.

As it is shown in Figure 7 that the trailer axle loads are the same. Taking into account (Čepukė *et al.* 2016) from statics equilibriums equations of the two support (Figure 8) beam and method of sections extremal internal forces are:
